**Oversight Hearing to Examine School Safety Issues within the
Bureau of Indian Education School System**

**Testimony of
Dr. Anthony Fairbanks
Superintendent**

The Laguna Elementary School presently has 273 Kindergarten through fifth grade students and was built in 1963. The Pueblo of Laguna Governor John Antonio and the Pueblo Council, the Laguna Department of Education board members, and the community of Laguna as a whole are very concerned about the structural safety of their elementary school. Due to the urgency of our concern for the safe and secure learning environments of our children and staff, the Pueblo of Laguna leadership has been working diligently with Mr. Jack Rever, Director of the Bureau of Indian Affairs Office of Facilities, Environmental and Cultural Resources Management for the past three years.

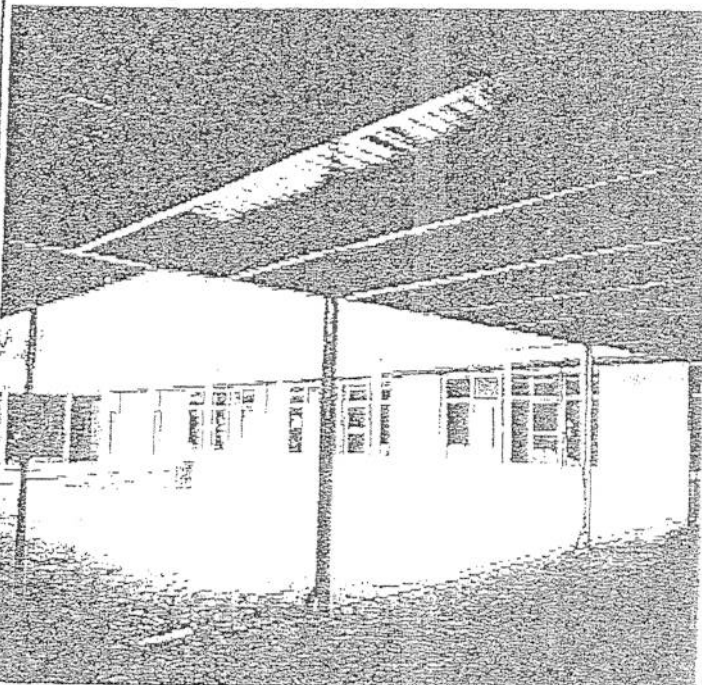
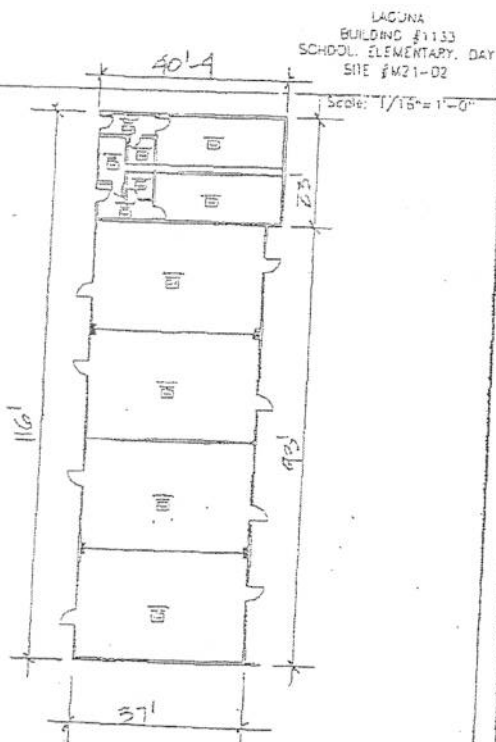
Bldg. Name: Laguna Day School, Bldg. 1133

Plan Irregularity is checked because the building's length is more than twice its width. Reinforcing verified with magnetic rebar finder. Historic registry is checked because building is over 30 years old. Foundation system is assumed. SL3 Assumed.

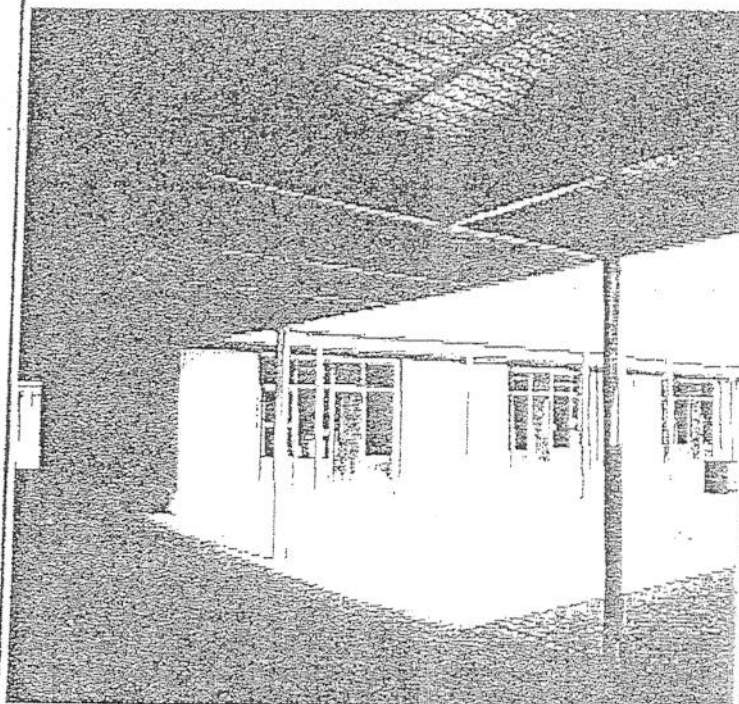
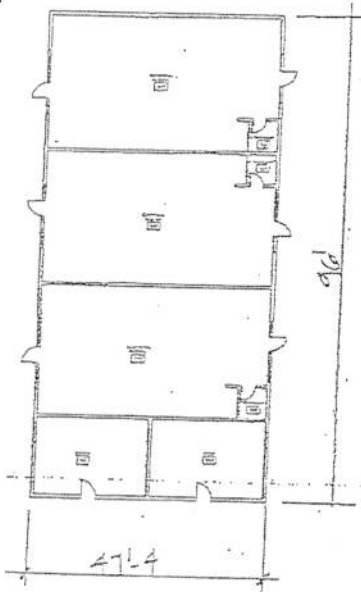
Bldg. Name: Laguna Day School, Bldg. 1132

RVS Notes:
 Plan irregularity is checked because the building's length is more than twice its width. Reinforcing verified with magnetic rebar finder. Historic registry is checked because building is over 30 years old. Foundation system is assumed. SL3 Assumed.

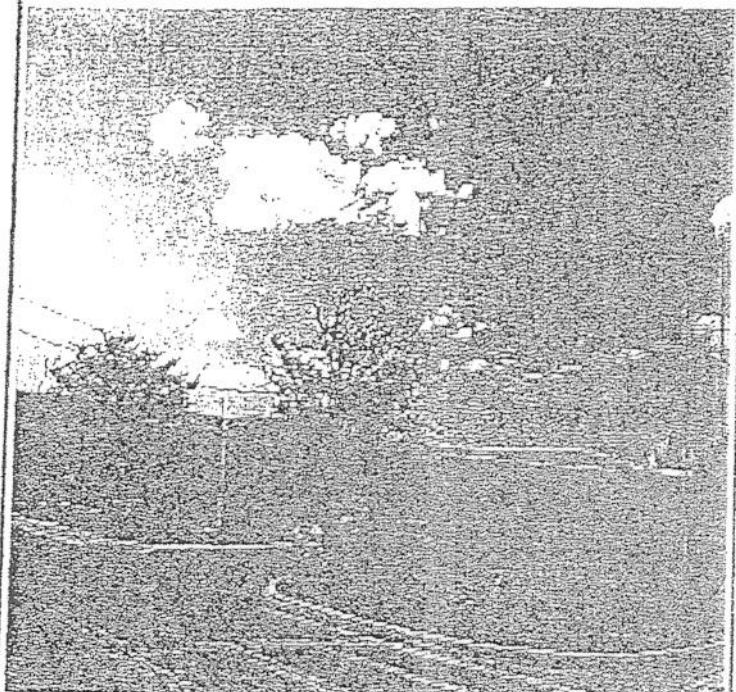
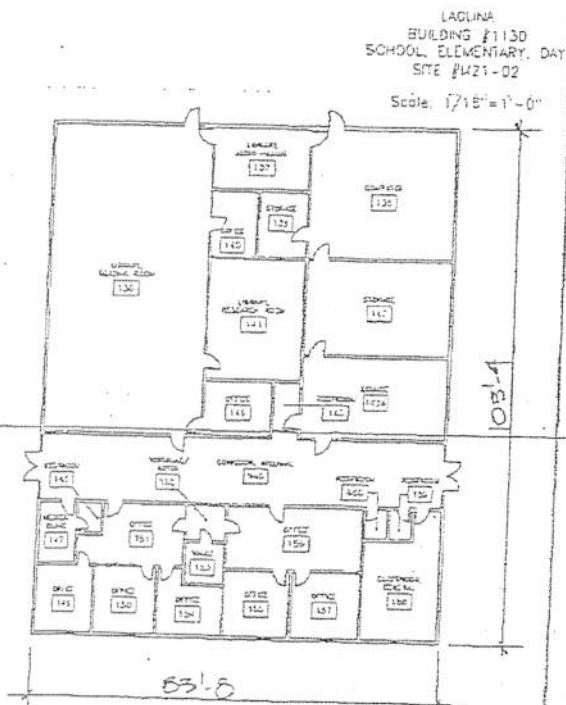
Bldg. Name: Laguna Day School, Bldg. 1130

RVS Notes:
 Reinforcing verified with magnetic rebar finder. Historic registry is checked because building is over 30 years old. Spread footing foundation is assumed. SL3 Assumed.

The Administration Building 1130 has some minor cracks around the perimeter of the building. The most notable occurs at the northeast corner of the building. The crack begins at masonry control joint at the east end of the north wall, and stair steps up two or three courses heading east. The east wall appears to be pushed out about a 1/2", right at the corner. This crack can be seen on both the interior and exterior face of the wall. We observed the concrete bond beam above the cracks and the beam is intact, with no noticeable cracks. As with Building 1135, there are minor cracks at the intersection of interior to exterior walls at several locations. It does not appear that new footings underpinning was installed under Building 1130 during the 1981 structural repairs. The exterior walls were supposed to be reinforced.

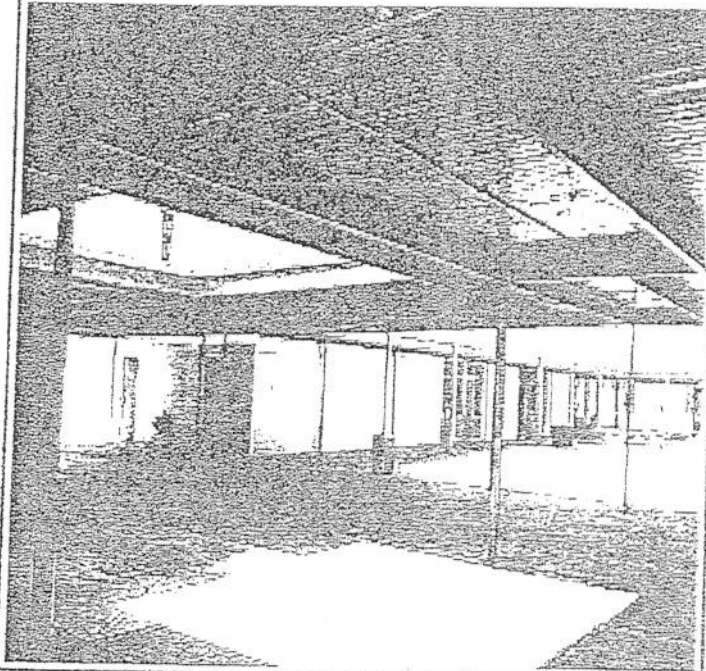
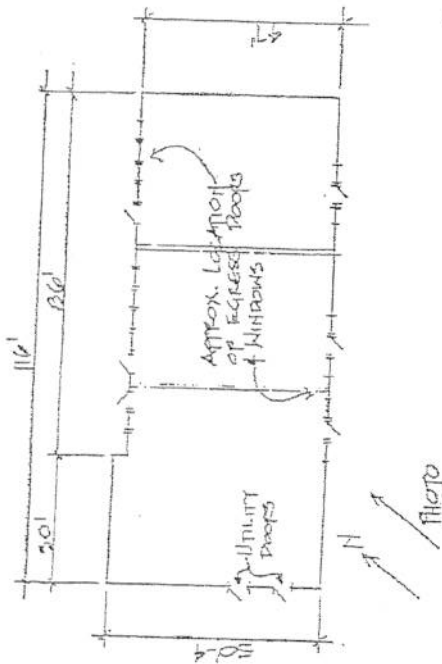
Bldg. Name: Laguna Day School, Bldg. 1131

At the Classroom Buildings (1131-1134), minimal cracking was observed. At Classroom Buildings 1131, on the south wall, at each end of the building, there is a crack through the wall, at the base of the wall. We do not know what caused these cracks, but they do not appear to be detrimental to the structural integrity of the wall.

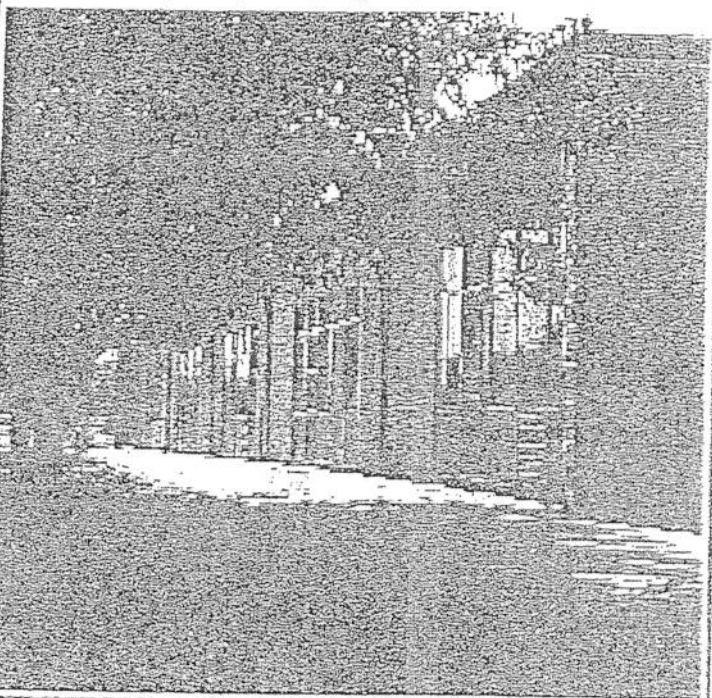
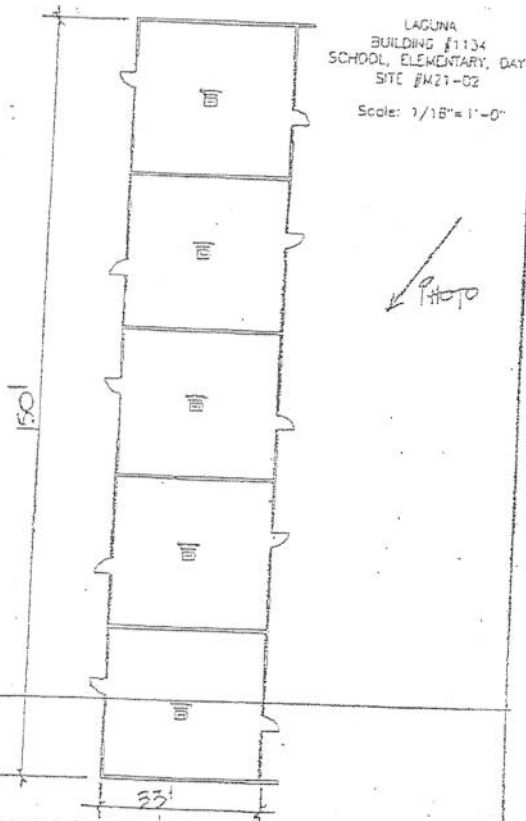
Bldg. Name: Laguna Day School, Bldg. 1134

Plan irregularity is checked because the building's length is more than twice its width. Reinforcing verified with magnetic rebar finder. Historic registry is checked because building is over 30 years old. Foundation system is assumed. SL3 Assumed.

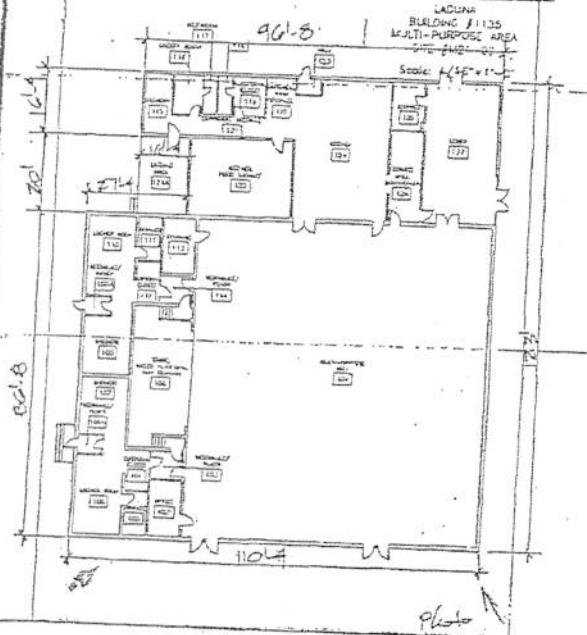
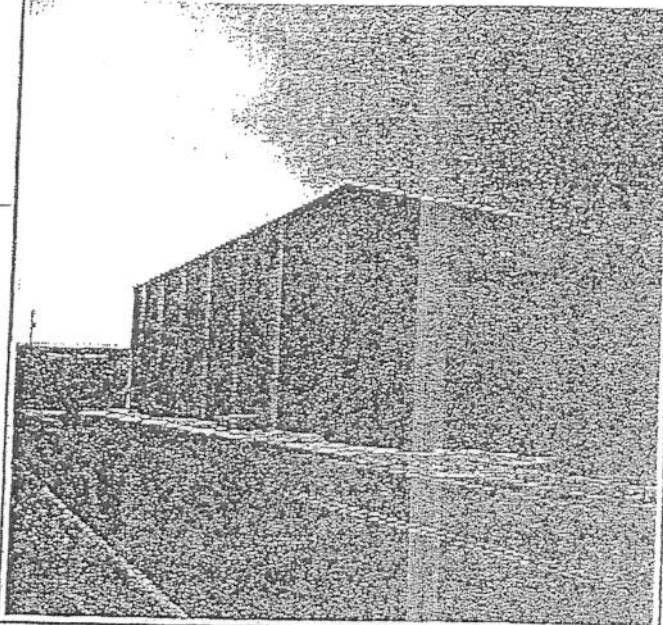
Bldg. Name: Laguna Day School, Bldg. 1135

Reinforcing verified with magnetic rebar finder. Poor condition is checked due to significant cracks in the CMU walls. Wide flange beams have been bolted to the exterior of the building that appear to be a retrofit to the original structure. Building contains a gymnasium, kitchen and dining facilities. It is also used for occasional assemblies. Historic registry is checked because building is over 30 years old. Foundation system is assumed. SL3 Assumed.

The Multipurpose Building 1135 has the most "cracking" around the perimeter of the building, especially in the high bay walls. Most of the "cracking" is occurring on the south and west walls, and the south end of the east wall. Per the original drawings, the walls around the high bay area of the Multipurpose Building are 12" thick x 16" long x 4" high un-reinforced concrete masonry units, with an 8"x 8" reinforced masonry bond beam at 10'-8" above finish floor and a concrete bond beam running around the top of the walls. No masonry control joints were observed in the Building 1135 walls. Except for some hairline vertical cracks, approximately in the middle width of the east and south walls, and some stair step cracks over duct penetrations on the west wall, none of the "cracking" observed on the exterior of the walls were observed on the inside of the walls. Most of the cracking observed on the exterior of Building 1135 was occurring along masonry mortar joints, where the paint over the joints were cracking and curling. In the interior of Building 1135, there are some minor cracks occurring at intersecting interior and exterior walls. The 1981 structure repair drawings indicated that new footings were to be installed around the perimeter of Building 1135, in addition to slide flange steel beams added to the exterior face of the east and south high bay walls. The new footings were to bear on basalt bedrock layer several feet below the bottom of the existing footings.

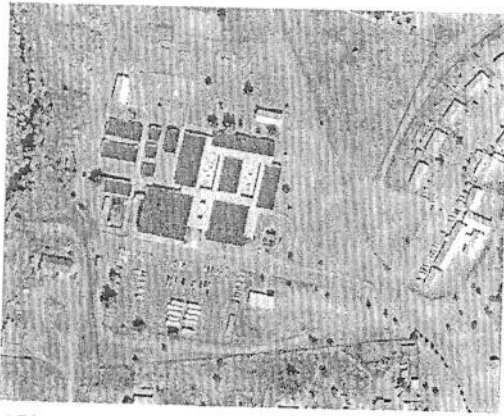
LES SITE VIEW

- Poor heating in classrooms
- Poor air ventilation
- Limited storage spaces for school supplies
- Limited to electrical outlet and power source
- Water heaters are exposed inside classrooms
- No overhead projectors
- Need space to grow plants. Heaters are near windows and kill all plants
- Security issues: too much glass, over heats rooms as well
- Need individual office spaces
- Need large nurses' offices
- Need therapy rooms

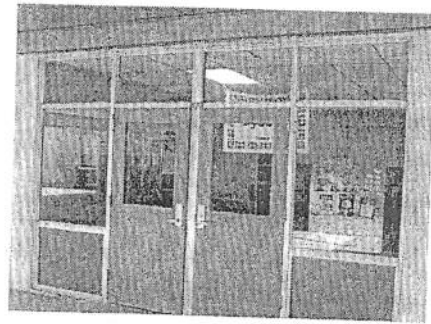
LES SITE "TOO MANY WINDOWS"

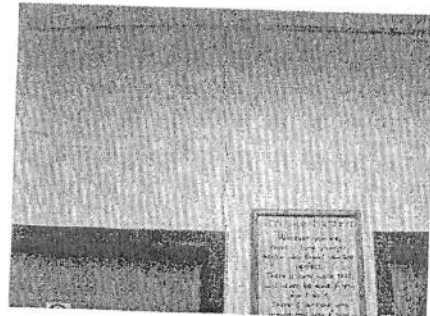
LES SITE—BUILDING SEPARATION

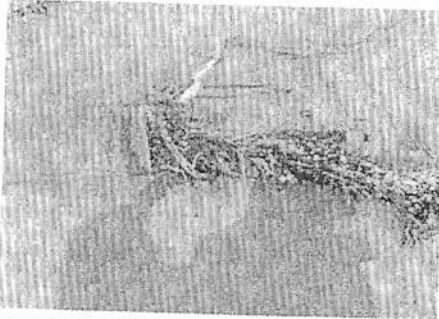
PIPE REPLACEMENT

The overall condition of the infrastructure is fair to poor due to the exceeding lifetime of use. There are deteriorated water and sewer lines requiring to be replaced periodically in sections. Many lines have been replaced due to backups from roots growing inside pipes. Most water lines are operational, however water pressure reducers are installed in both the Early Head Start and Elementary School.

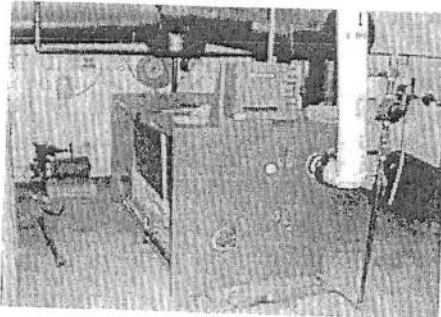
OLD BOILER

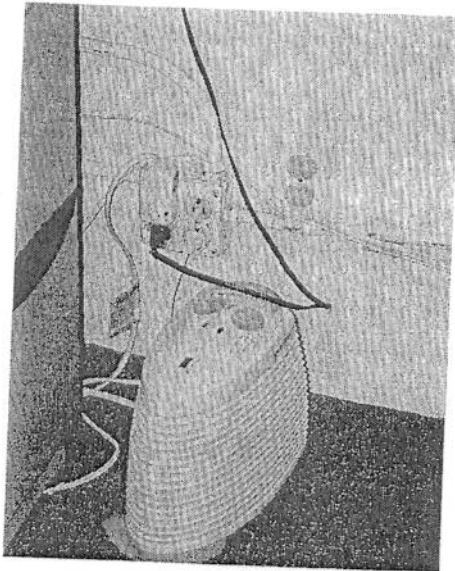
EXPOSED ELECTRICAL

The Elementary school has maximized the power capacity and cannot add any additional circuits. The buildings have exposed electrical wiring in conduits where additional circuits were brought in to meet demand. The elementary school is operational with obsolete electrical equipment; breakers and panels have been repaired and cannot be replaced due to the entire equipment being obsolete. This issue limits curriculum possibilities in education which diminishes student productivity.
