Rapid Assessment of Soil Metal Concentrations Along the Animas River, New Mexico

David C. Weindorf¹ Kevin Lombard²

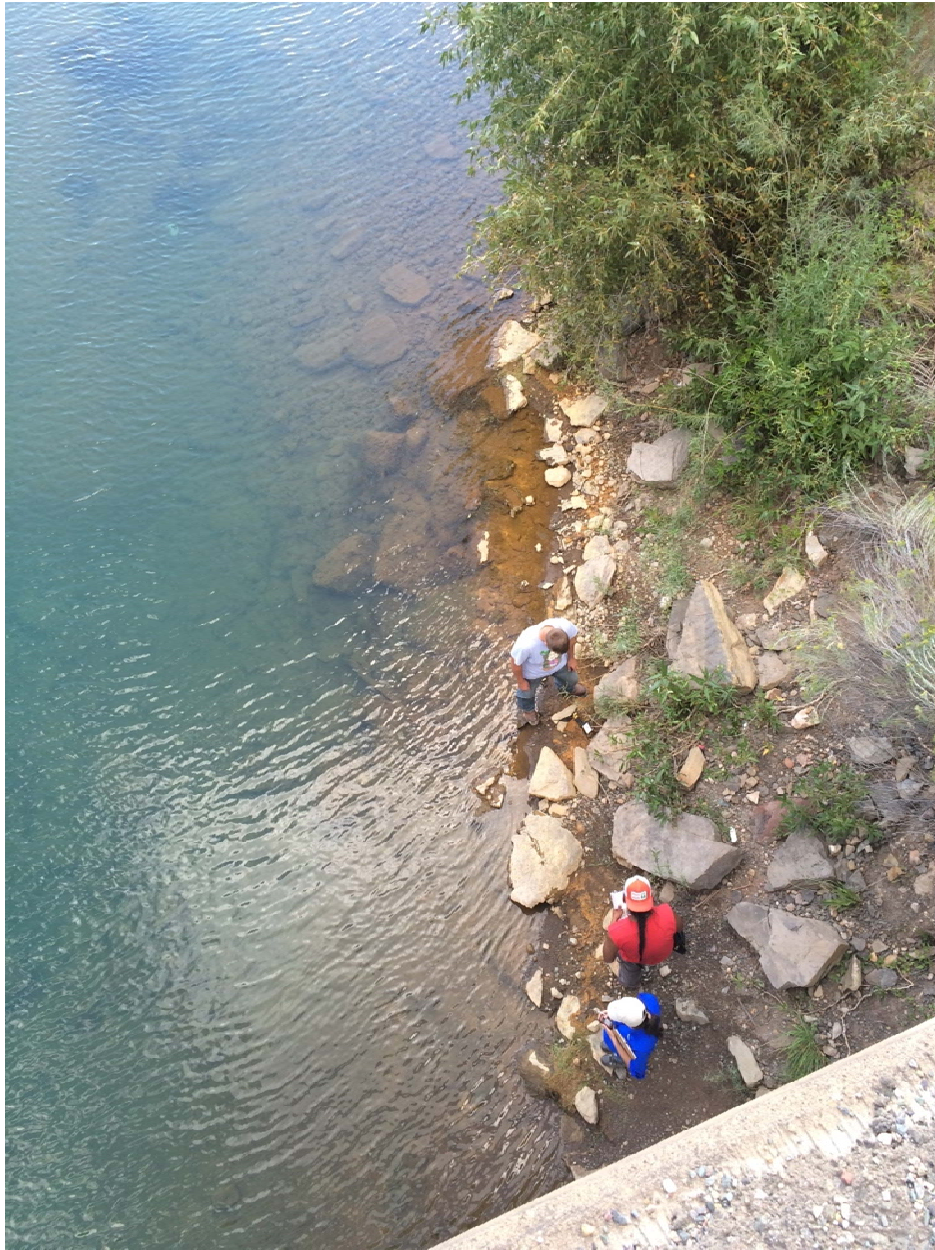
Fig. 1. Clear Animas River water north of Durango, Colorado showing remnants of the reddish orange colored sludge both along the river banks as well as submerged underwater.

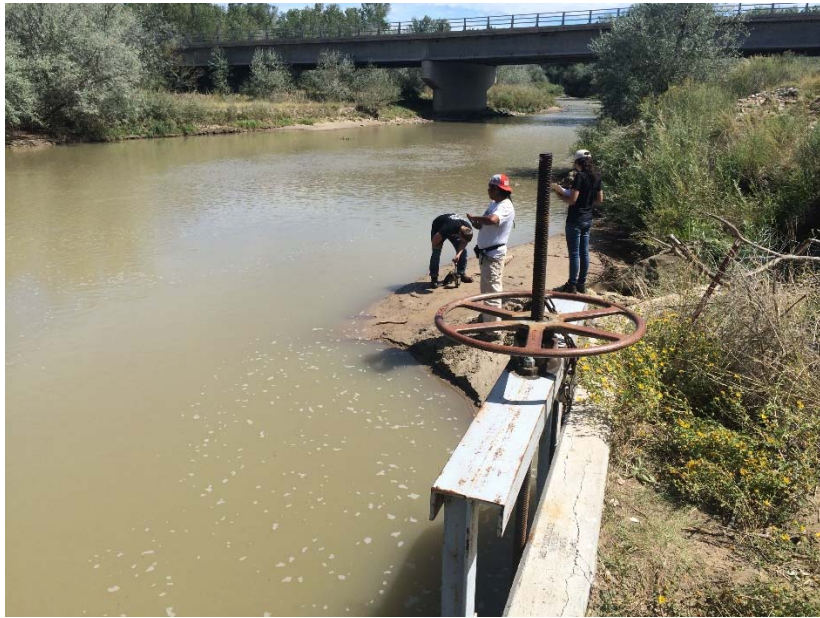
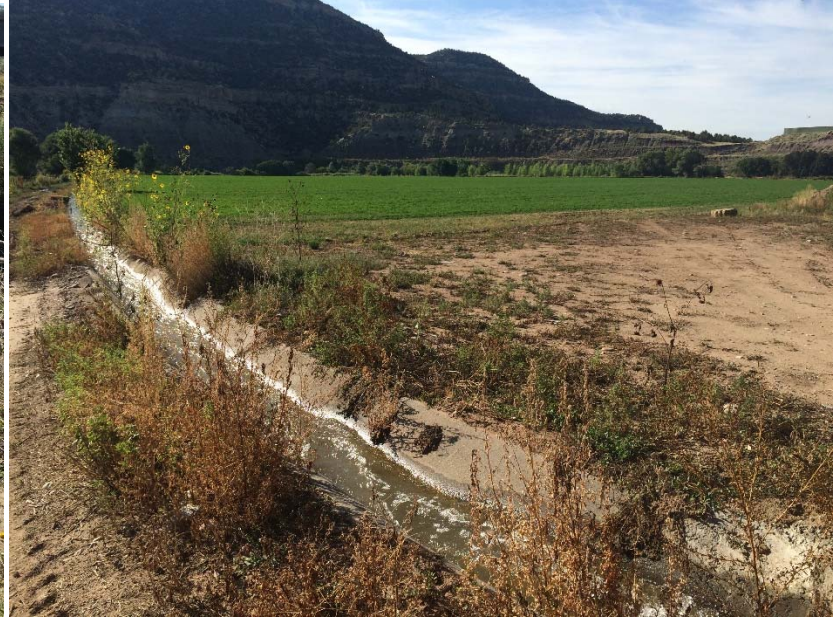
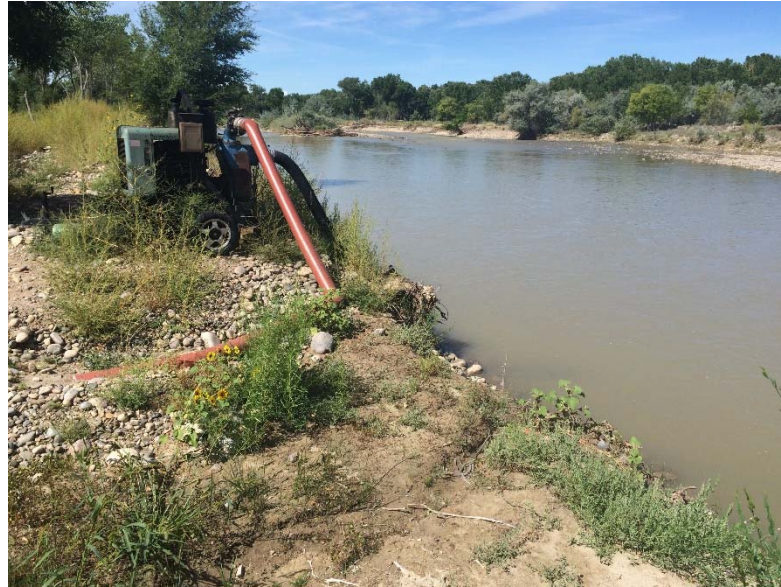
Fig. 2. Irrigation ditches and pumps of the Animas River Valley used for spreading river water to farm fields.

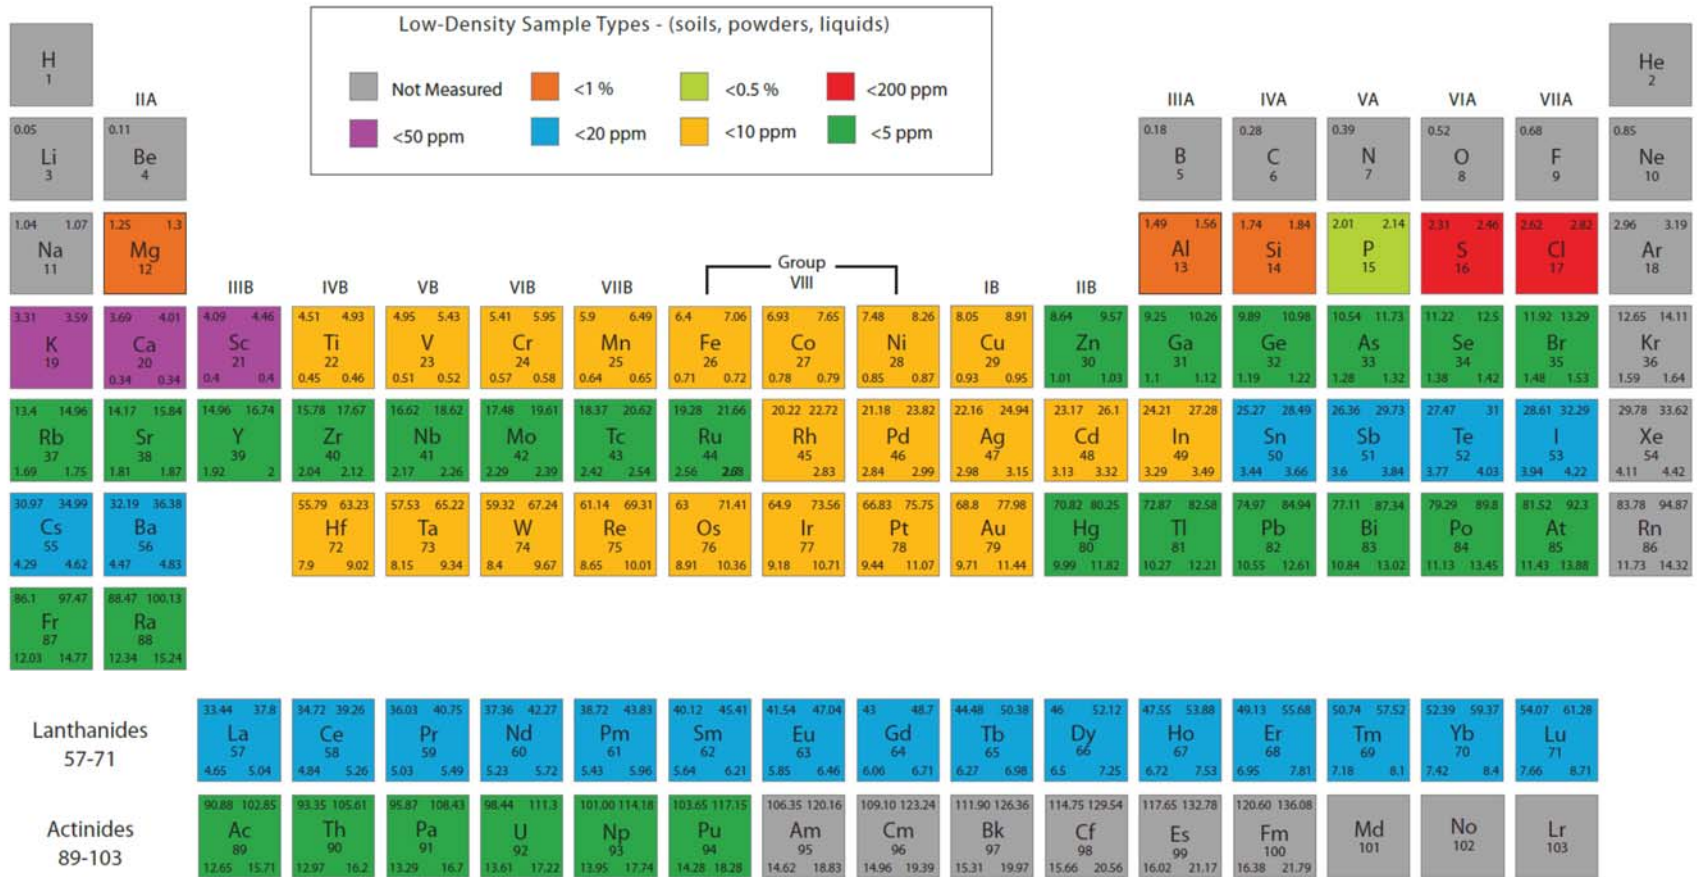
Limits of Detection

Fig. 3. Generalized limits of detection for the Delta PXRf by Olympus.

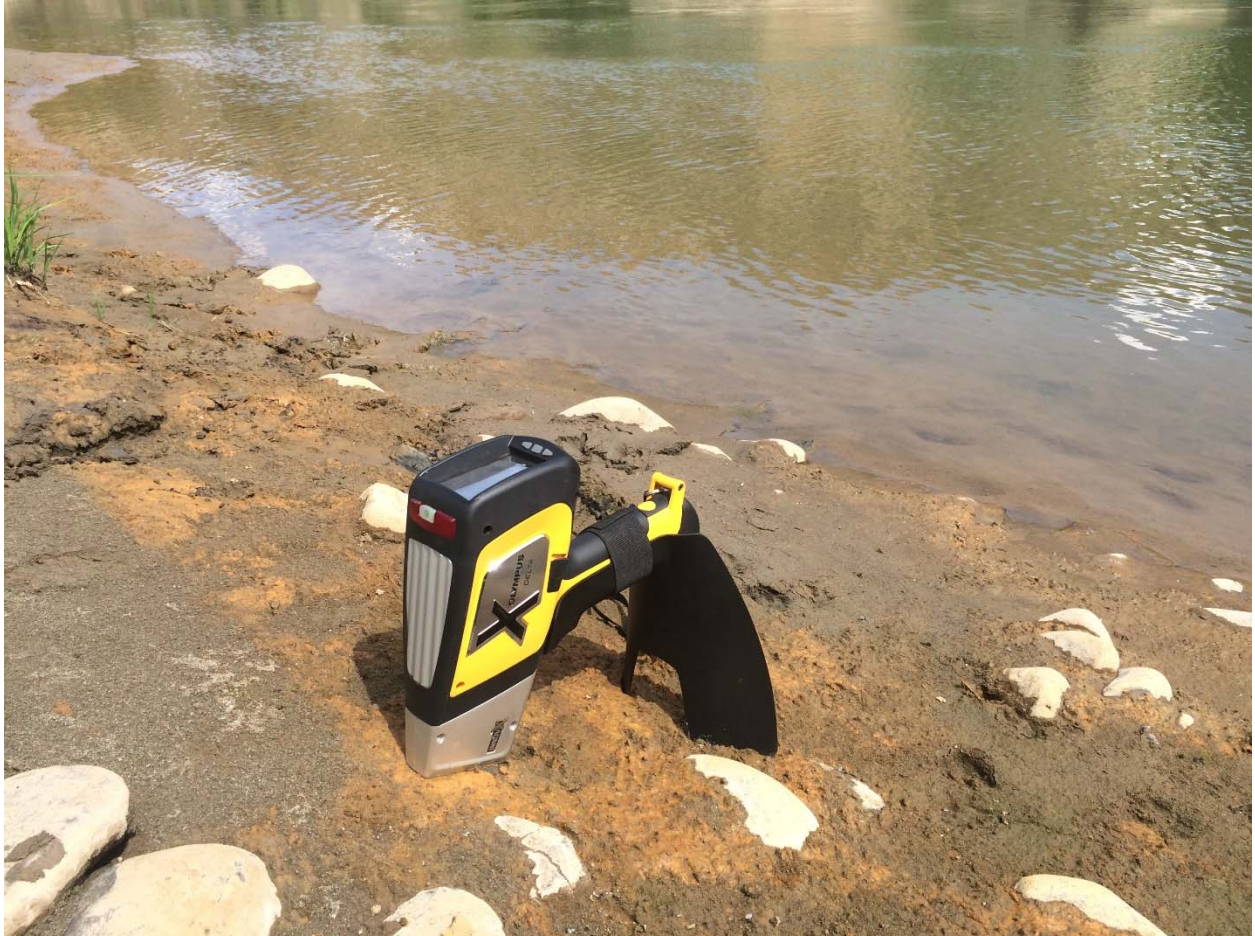
Notably, we found and identified the properties of the river sludge sent down the Animas River. Generally, it has Pb levels of ~600-800 mg kg⁻¹; and higher levels of Fe, Cu, and Zn. The residential screening limit for Pb in soils is 400 mg kg⁻¹ (Brevik, 2013). These sludge materials were found both in New Mexico and Colorado, both on the stream banks and underwater (Fig. 4). Irrigated lands along the Animas River tended

Fig. 4. Assessment of sludge laden sediment with portable x-ray fluorescence spectrometry along the banks of the Animas River in New Mexico.

Summarily, the level of metals found in sludge along the Animas River warrants careful observation. Certainly, cleanup of the sludge is recommended in areas where it is apparent and accessible. Nonetheless, it is highly likely that small amounts of metal will continue to work their way downstream intermixed in alluvial sediments for the next several years (Fig. 5). This poses a risk of accumulation in soils whereby Animas River water is used for irrigation. Extensive spatial and temporal sampling are recommended such that the levels of metals in soils of the Animas River Valley will be more thoroughly understood in an effort to protect and optimize soil health. If areas of accumulation are noted, phytoremediation or other remediation strategies should be undertaken to ensure that the metal laden soils do not pose a risk for metal bioaccumulation in plants or feedstocks used by humans or animals.

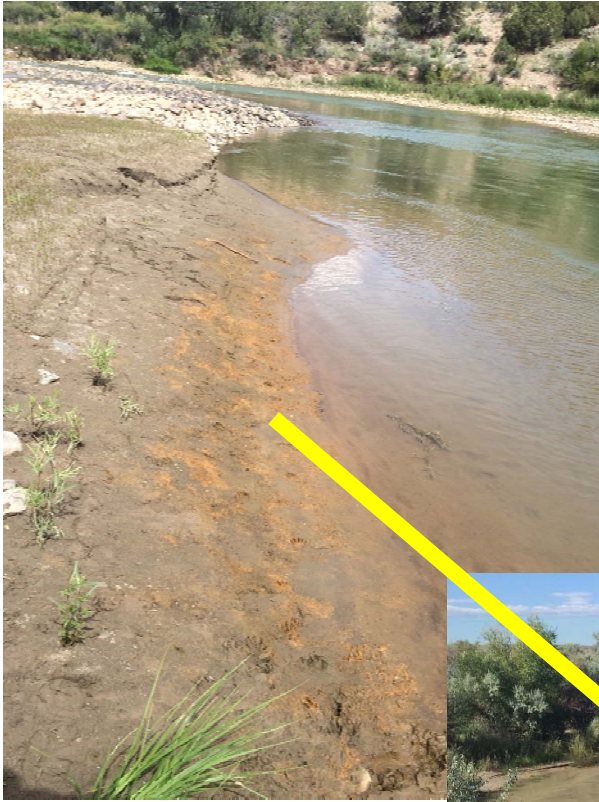
Fig. 5. Schematic showing how metal laden sludge along the Animas River can pose a threat to soil quality of irrigated lands in the Animas River Valley. As sediment along the riverbank washes into the river and becomes suspended, there is a high likelihood that the suspended sediments would then be dispersed across adjacent farm fields which depend on the Animas River water for irrigation.
