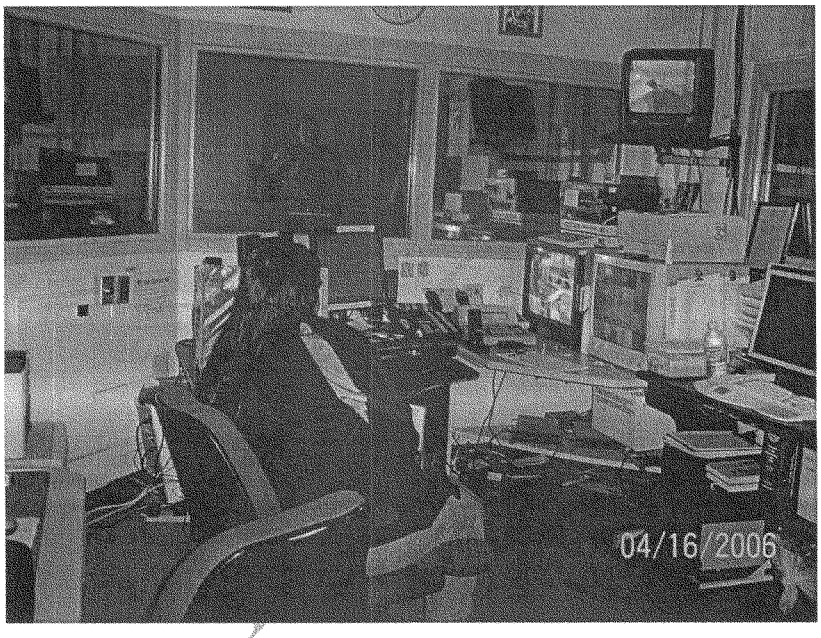
Dispatch at her workstation with the security camera monitors that are being monitored by the detention officer noted in the picture above

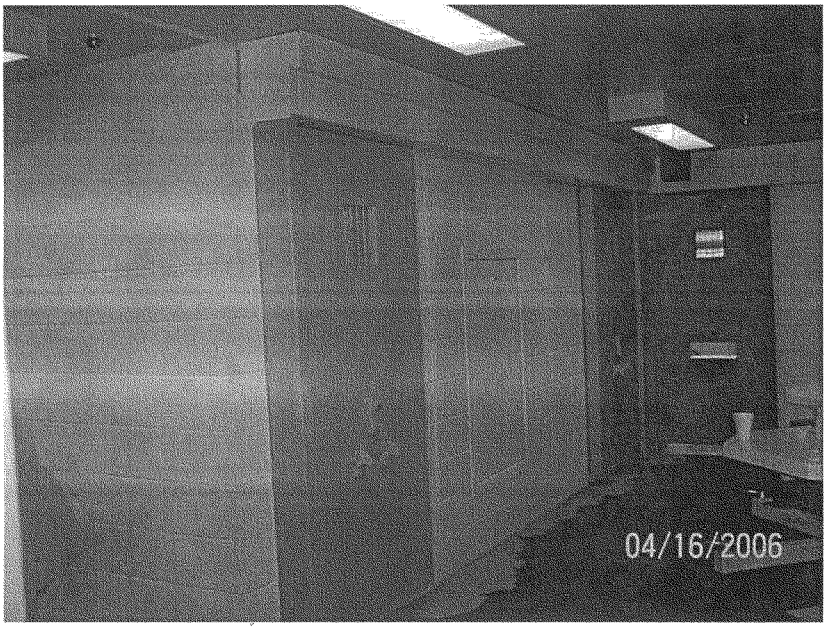
Locked cell doors without a mechanical override.

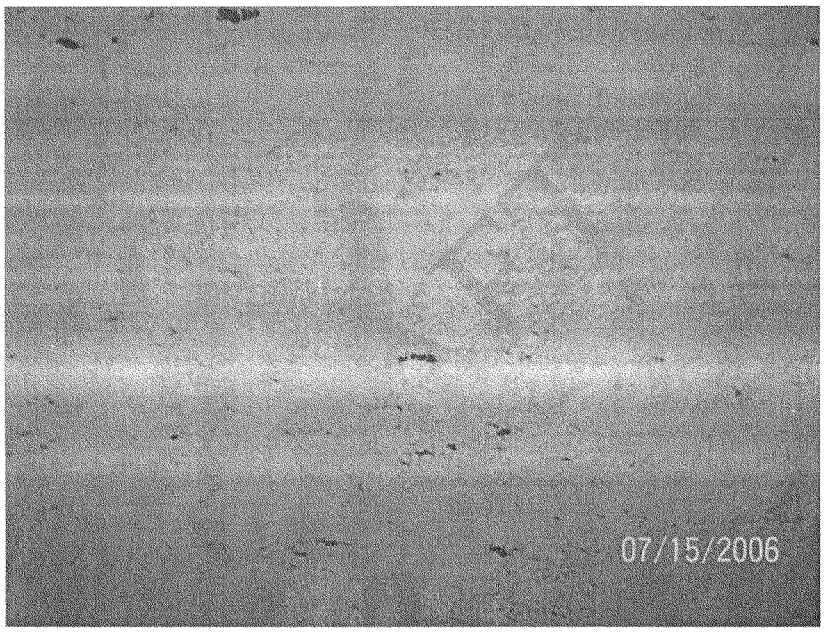
Blankets worn out but in continued use

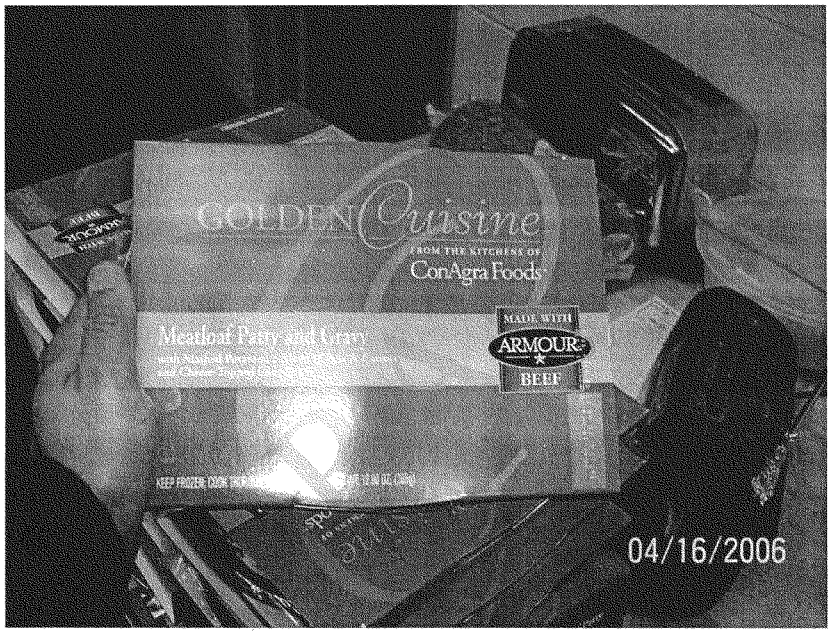
Inadequate lunch
